# Slide Glide Bearing Repair

Lt Dan

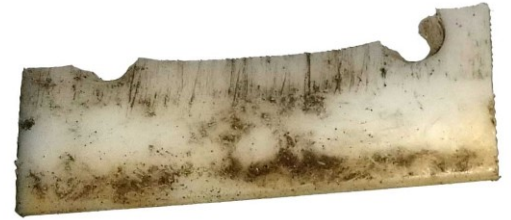
If you find a nylon piece that looks similar to Photo 1 lying around the coach or inside one of the bays, then you have a slide glide problem. Each of the hydraulic slide rams has two nylon glide “bearings” underneath at the outside edge of the coach. These are a common failure item and usually break along a line between the mounting screws. They support the full weight of the slide when it’s extended so they can fail. Another sign of a broken glide is scoring by the exposed screw heads under the ram. See Photo 6 or the before photo on page two for illustration. The Tiffin replacement part number is 5040508 and the HWH part number is RAP93601.

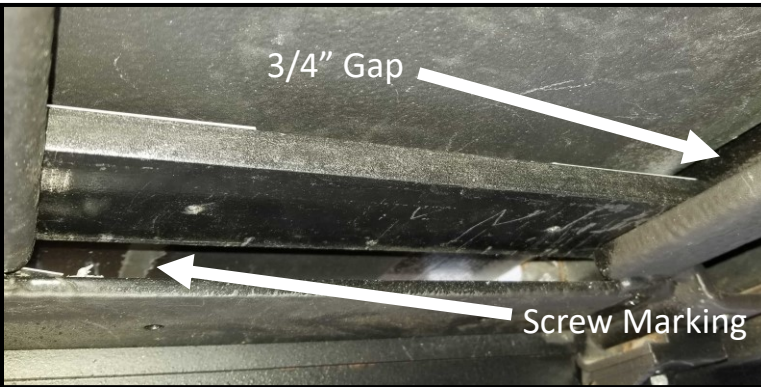
Photo 6

This is the gap that raising the ram on the outside creates. It needs to be about 3/4" to allow the block to come out and then go back in with the new glides.
