Check Your Valve Stems!

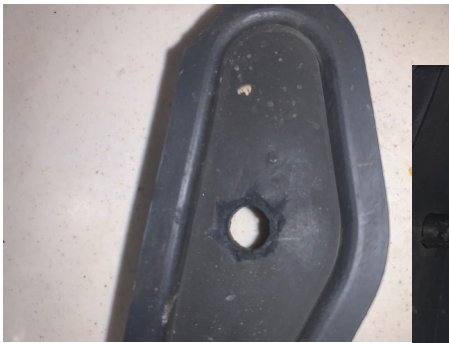
Two different instances of sudden tire deflation have occurred in our “small” club. Both of these were due to the failure or movement of the valve stem stabilizer on the inner rear wheel. This rubber stabilizer is there to keep the valve stem extension from moving around and contacting the wheel. If the valve stem comes in contact with the wheel while moving, it can eventually cause a hole to be worn in the metal extension. Luckily both of these occurrences were caught by the TPMS (Tire Pressure Monitoring System). That’s another tech bulletin, but a TPMS is highly recommended as you can run on a flat dual tire or one on the towed vehicle and never know it until something major happens.

This one belonged to Ron Hawkins.

The rubber stabilizer has been known to fall out of the hole in the wheel so a bead of silicone adhesive around the edge before installing it in the wheel is recommended. Make it part of your pre-flight routine to check those inner valve stems.

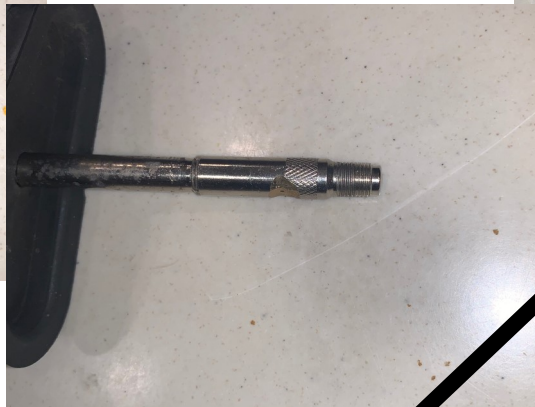
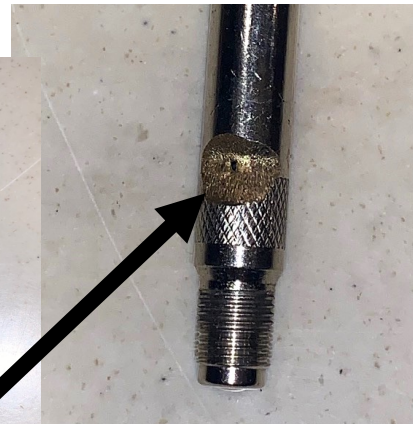
Holes worn in valve stems.

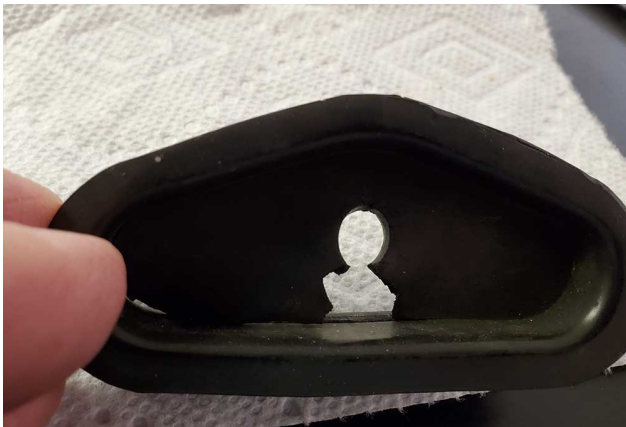
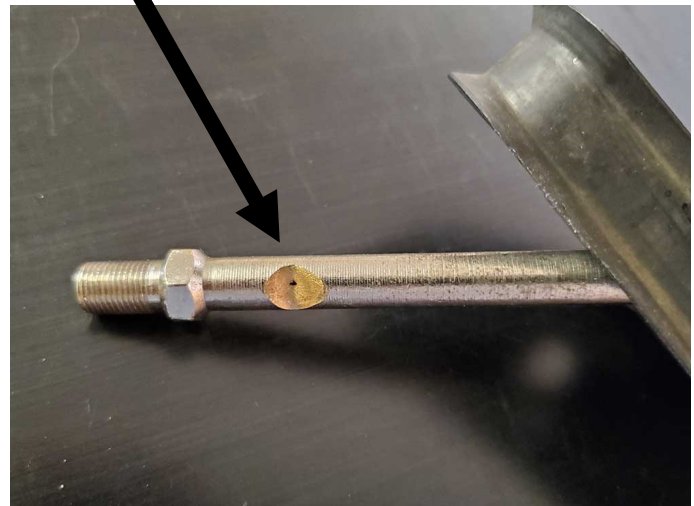
This one belonged to Jim Grinstead.
